EVALUATION OF STRUCTURAL LAYERS IN FLEXIBLE
PAVEMENT

ARMY ENGINEER WATERWAYS EXPERIMENT STATION

MISCELLANEOUS PAPER S-73-26

May 1973

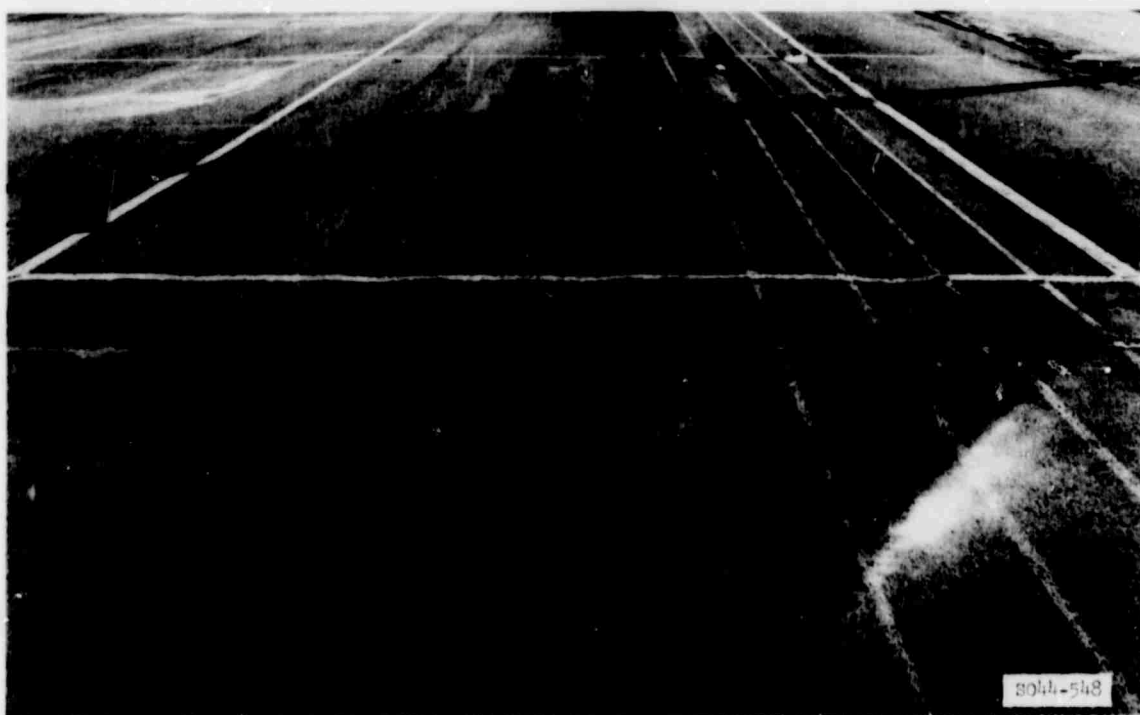
Photo B2. General view of item 1, lane 1, at failure (after 198 coverages of 360-kip, 12-wheel assembly)

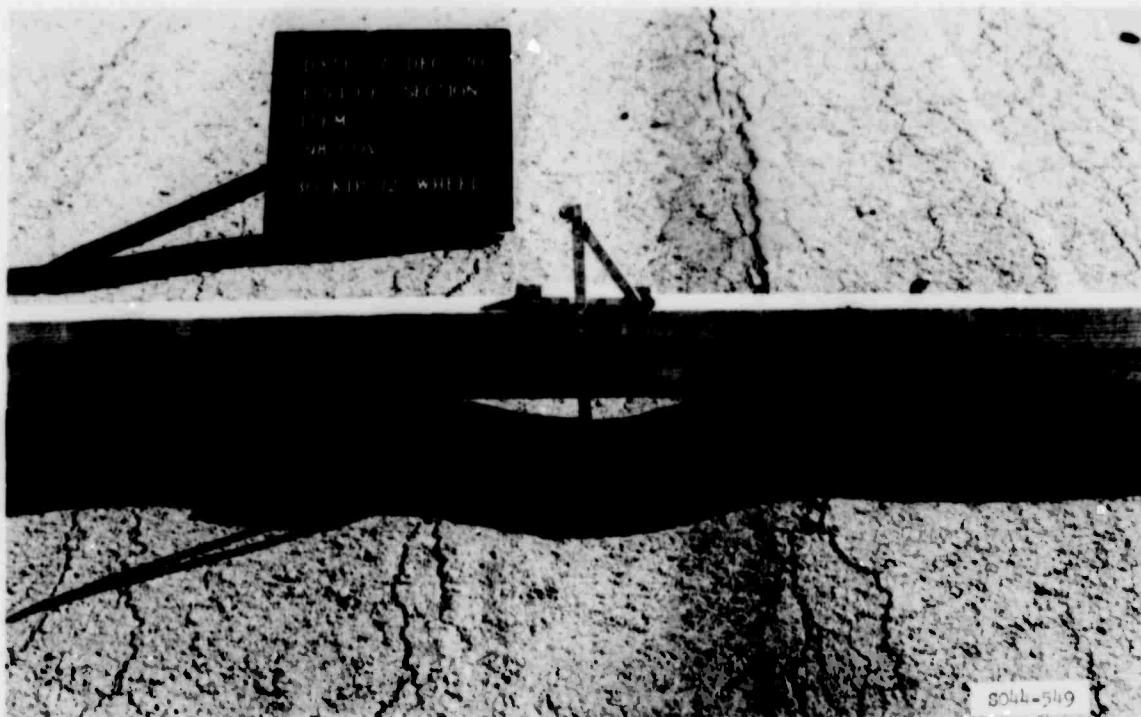
Photo B3. View of the severe cracking in item 1, lane 1, at failure

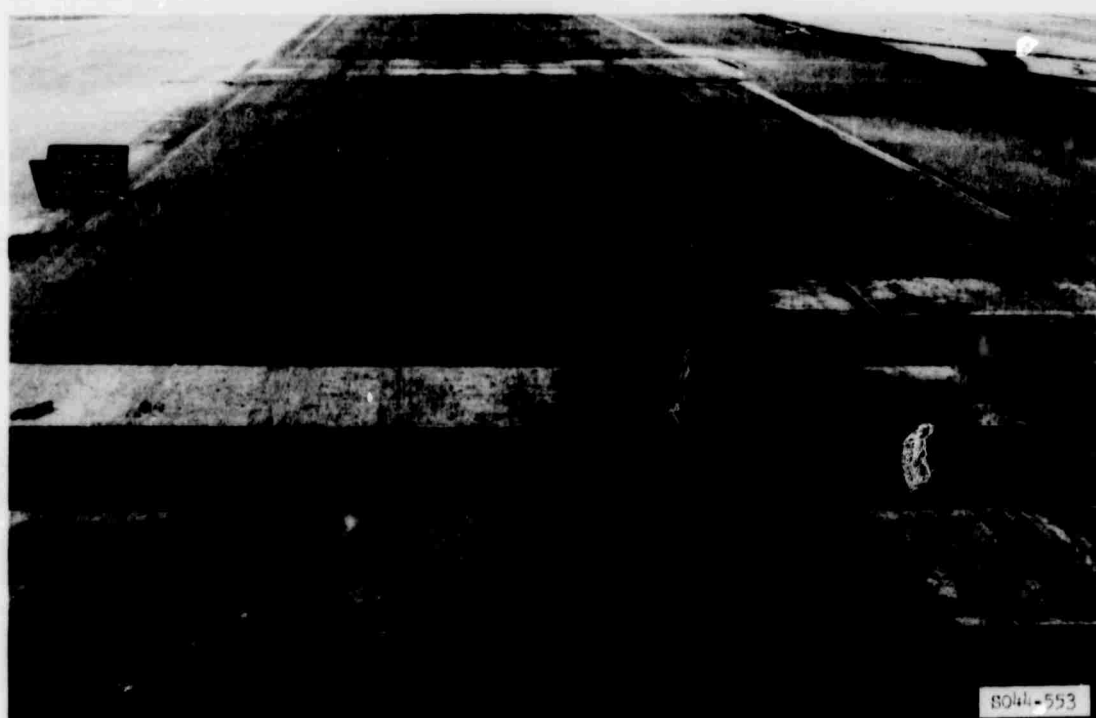
was considered failed at 1200 coverages, traffic was continued to 1342 coverages (photo B6).

Photo B6. General view of item 2, lane 2, after 1327 coverages of 360-kip, 12-wheel assembly (failed at 1200 coverages)

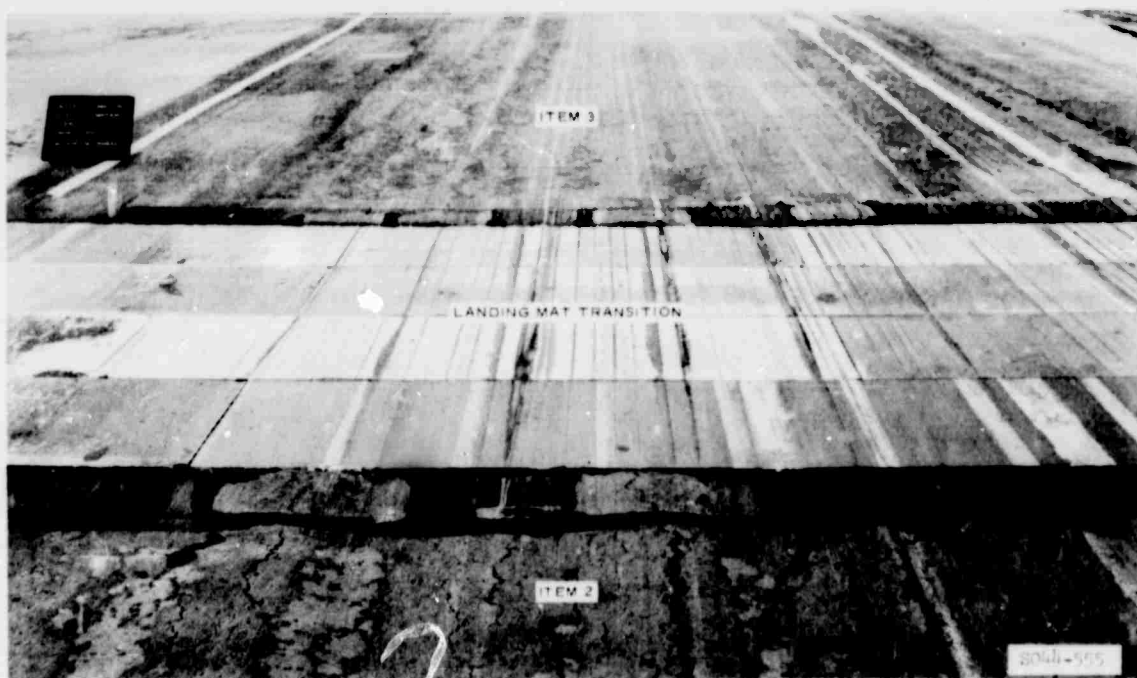
Photo B8. General view of item 3, lane 1, after 1509 coverages of 360-kip, 12-wheel assembly. Note cracks in item 2 in foreground

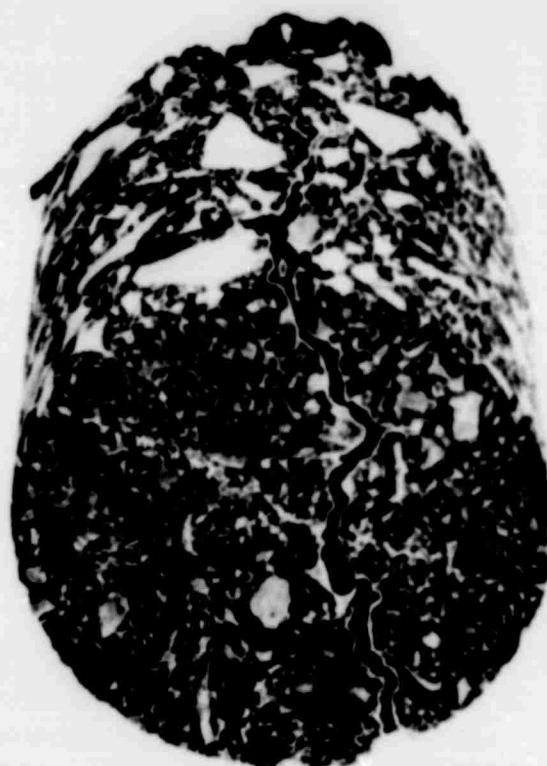
Photo B10. One-in.-deep crack in core from 100 percent coverage zone of item 3, lane 1 (after 2744 coverages of 360-kip, 12-wheel assembly)

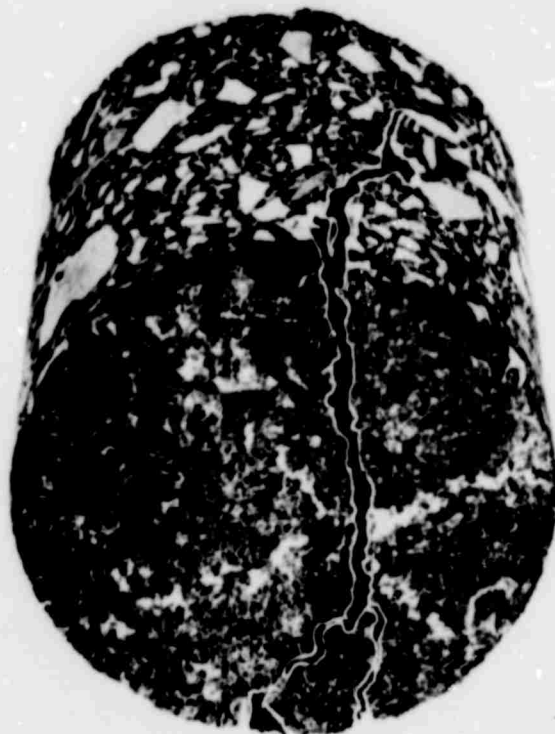
Photo B11. Core taken at construction joint in item 3, lane 1 (after 27 $\frac{1}{4}$ coverages of 360-kip, 12-wheel assembly). Crack depth about 1- $\frac{3}{4}$ in.

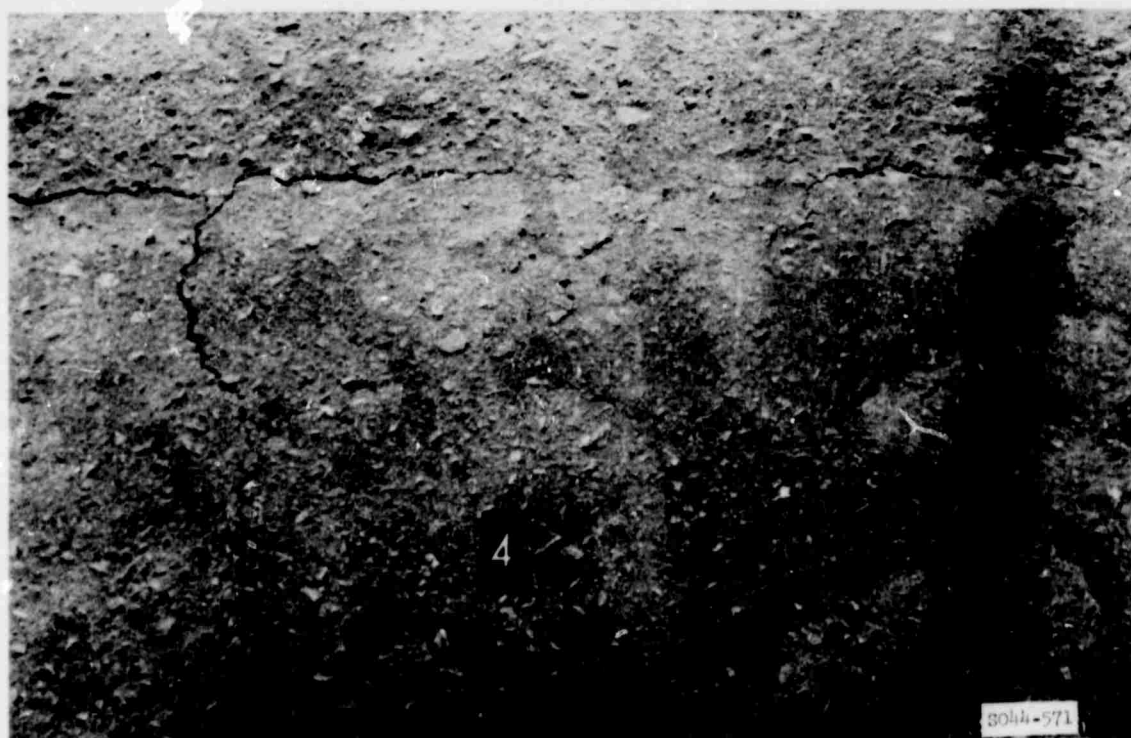
Photo B14. Small cracks extending from construction-joint crack in item 4, lane 1, after 10,406 coverages of 360-kip, 12-wheel assembly

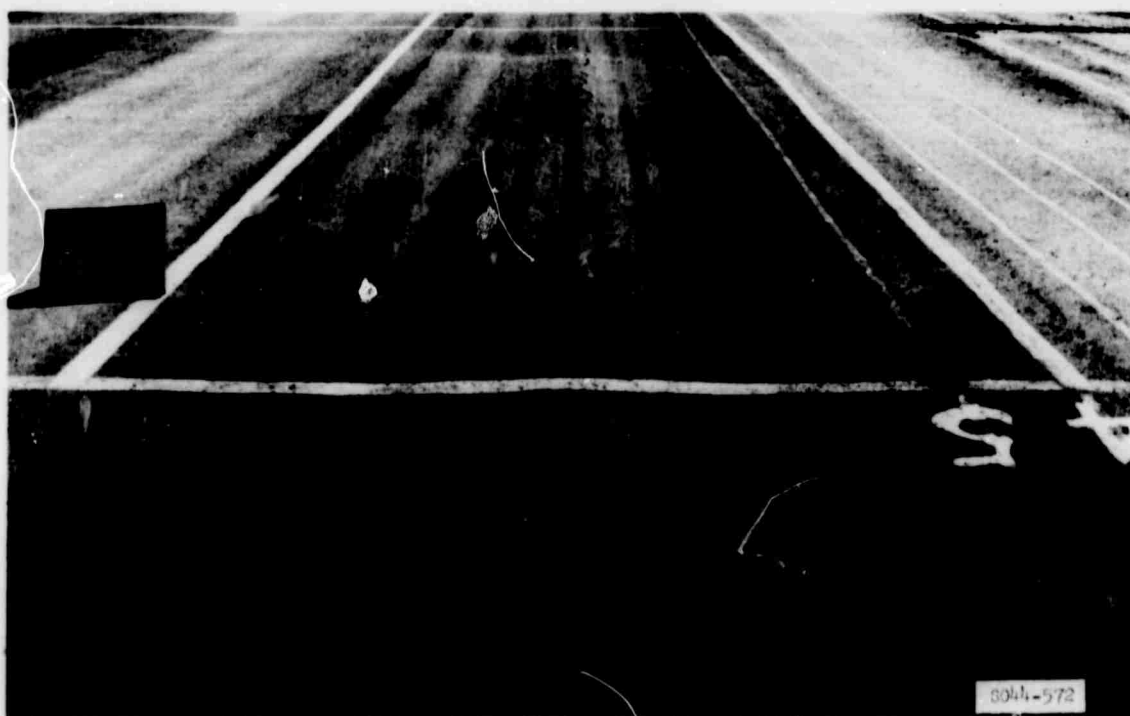
Photo B16. General view of item 1, lane 2, at failure (after 140 coverages of 160-kip, twin-tandem assembly)

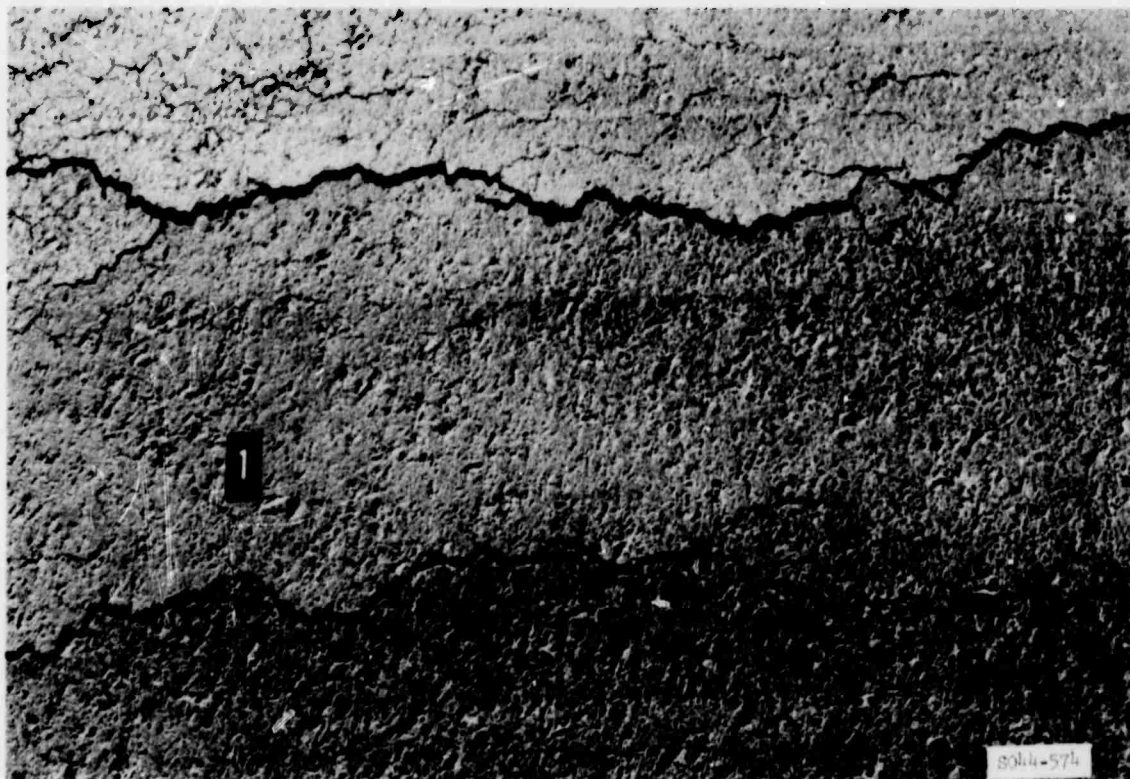
Photo B17. Close-up of cracks in 100 percent coverage zone in item 1, lane 2, at failure (after 140 coverages of 160-kip, twin-tandem assembly)

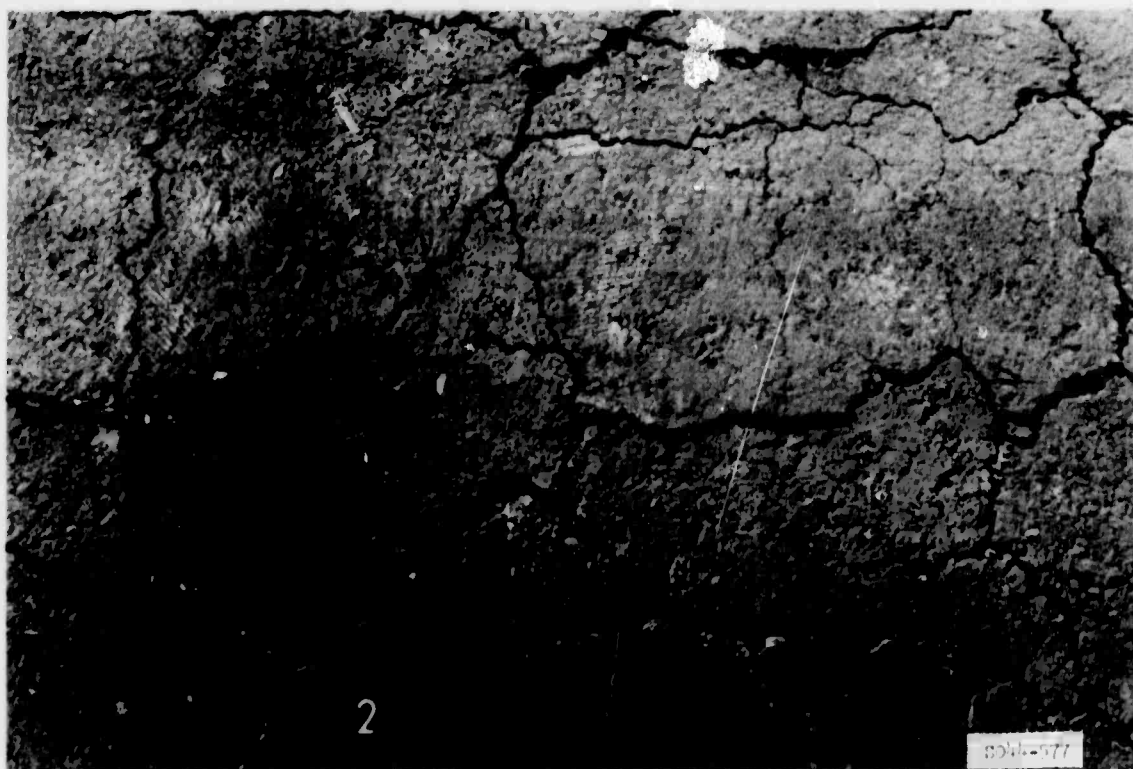
Photo B19. 1/4-in.-wide alligator-type cracking in 100 percent coverage zone of item 2, lane 2, at failure (after 1000 coverages of 160-kip, twin-tandem assembly)

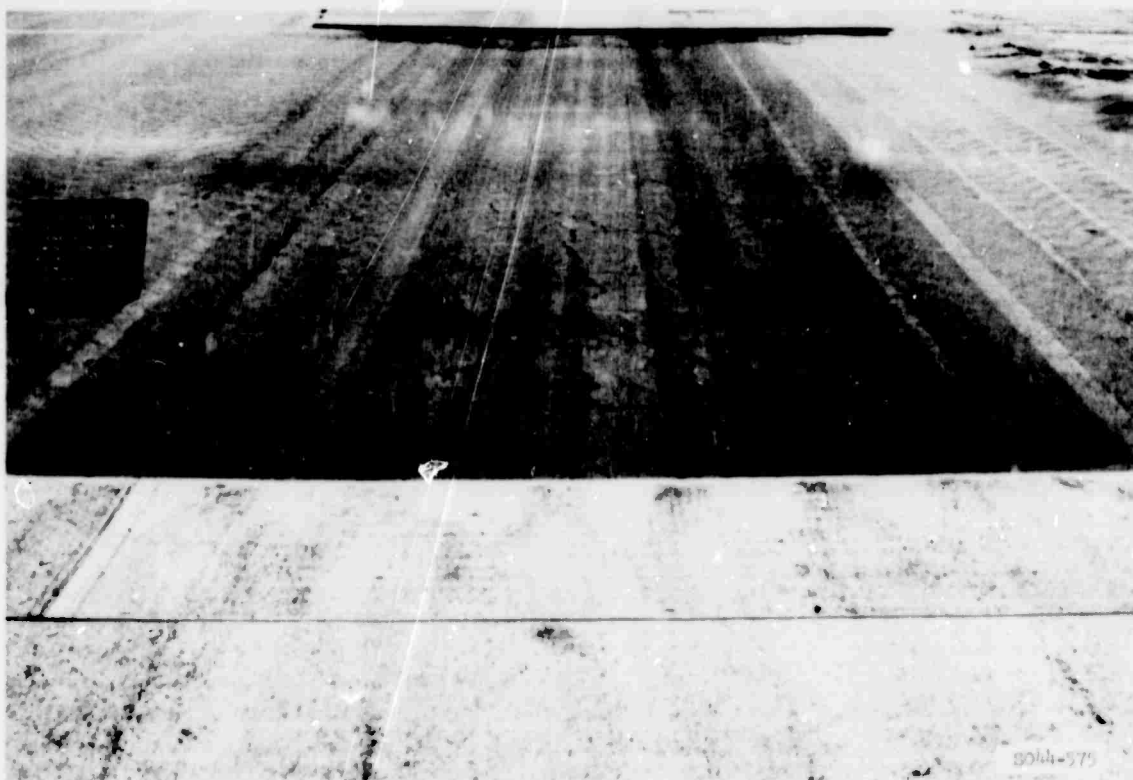
Photo B20. General view of item 2, lane 2, at failure (after 1000 coverages of 160-kip, twin-tandem assembly)

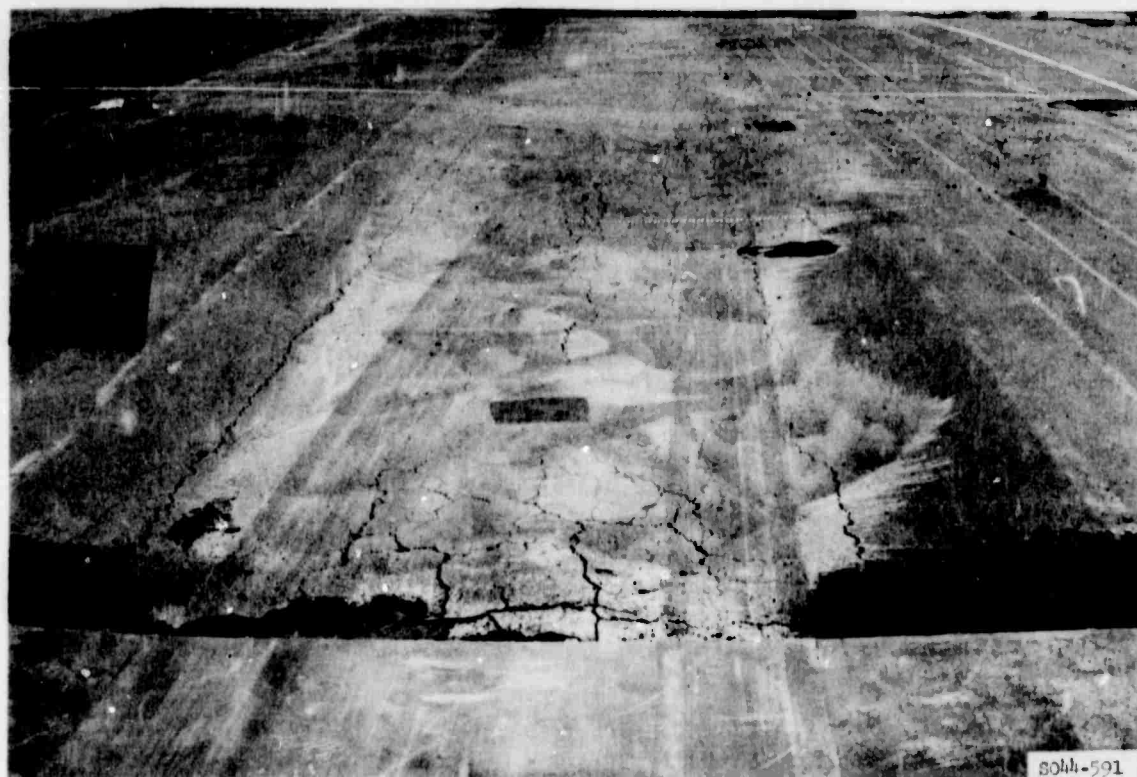
Photo B24. General view of item 3, lane 2, at failure (after 890 coverages of 200-kip, twin-tandem assembly)

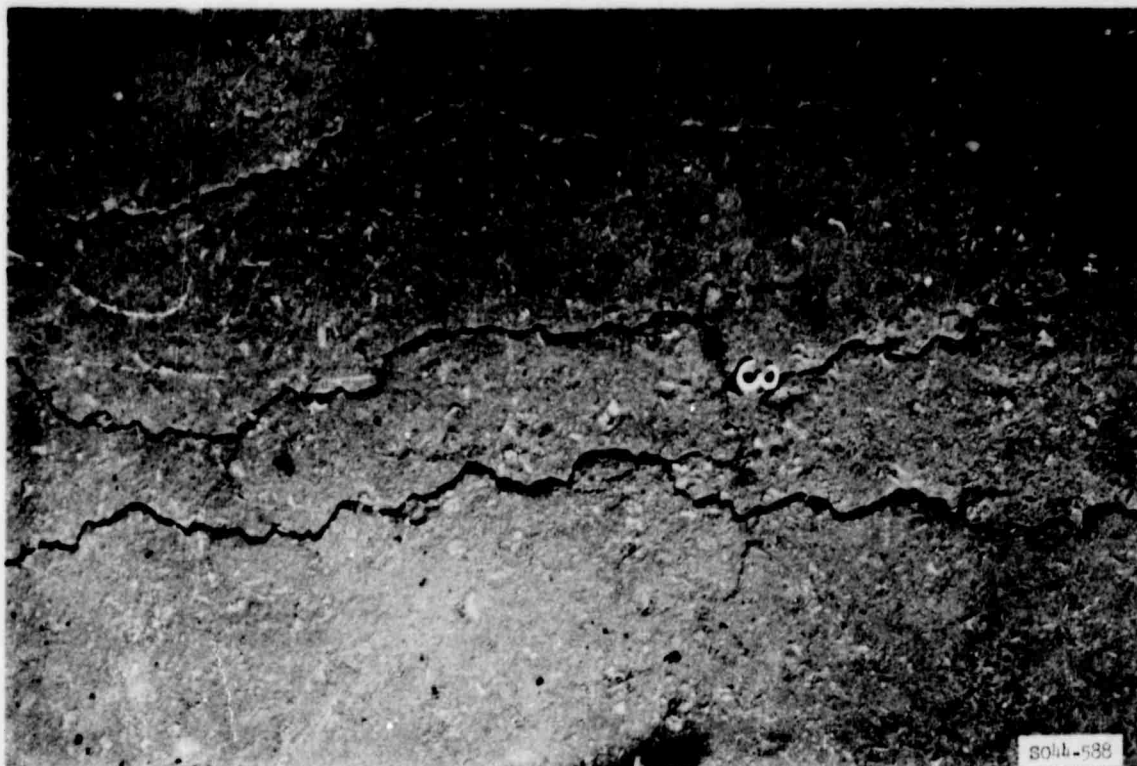
Photo B25. Close-up of cracks in 100 percent coverage zone in item 3, lane 2, at failure

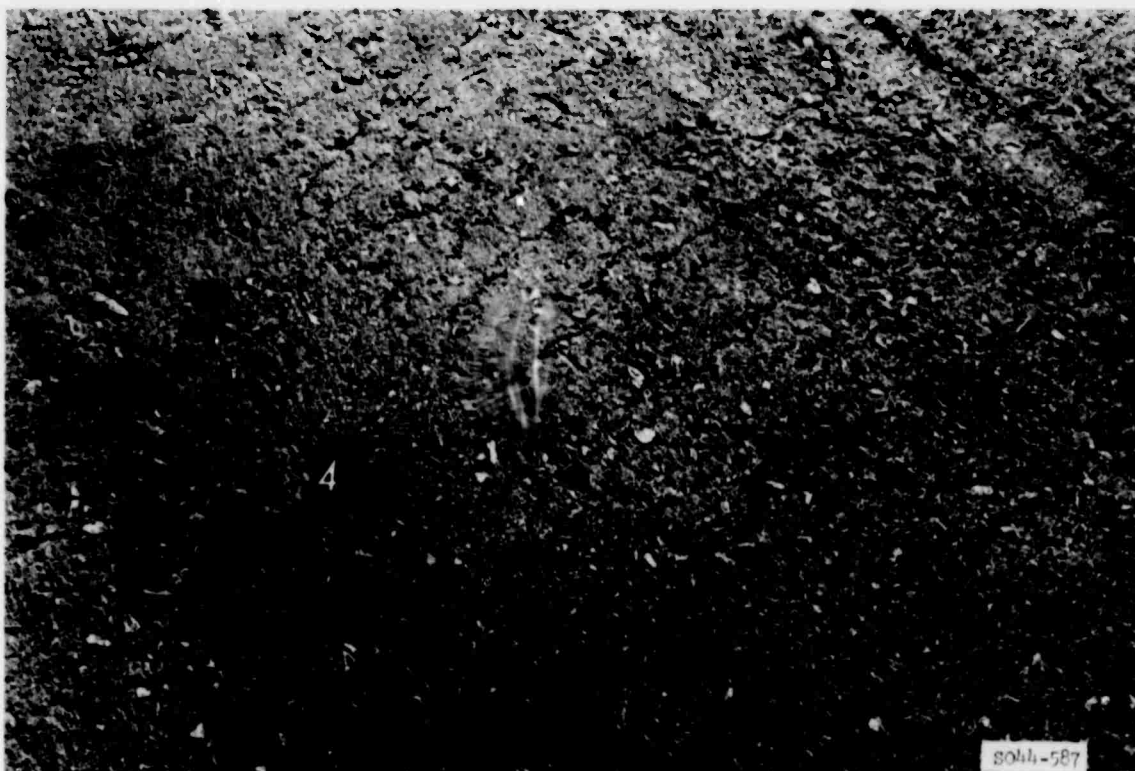
Photo B26. Small hairline cracks transverse to direction of traffic in item 4, lane 2, after 560 coverages of 200-kip, twin-tandem assembly

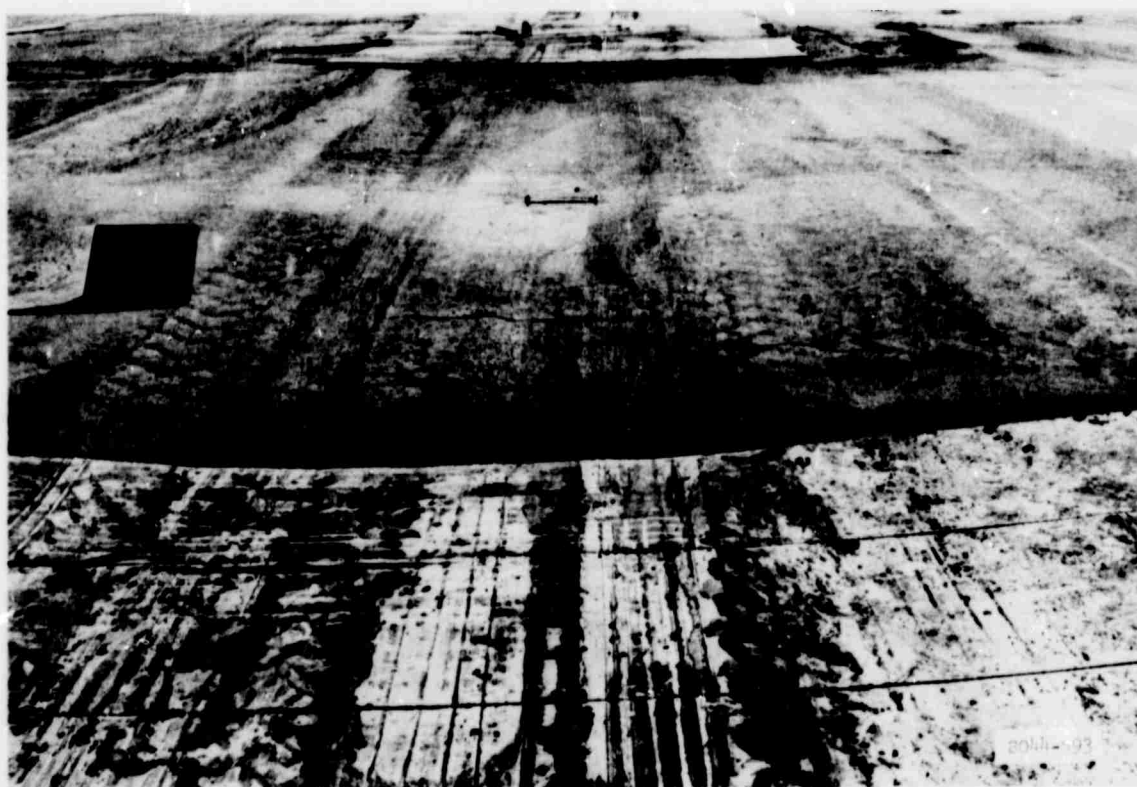
Photo B27. General view of item 4, lane 2, at failure (after 1810 coverages of 200-kip, twin-tandem assembly)

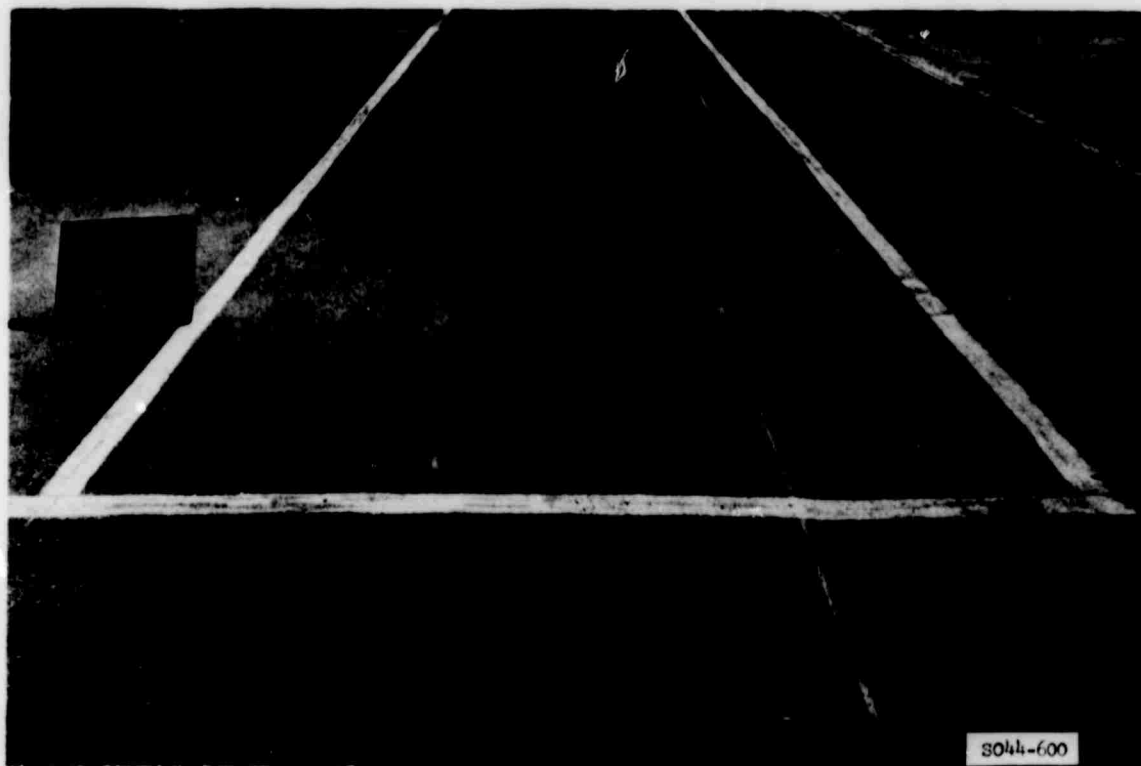
Photo B29. Item 1, lane 3, at failure (after 40 coverages of 50-kip, single-wheel assembly)

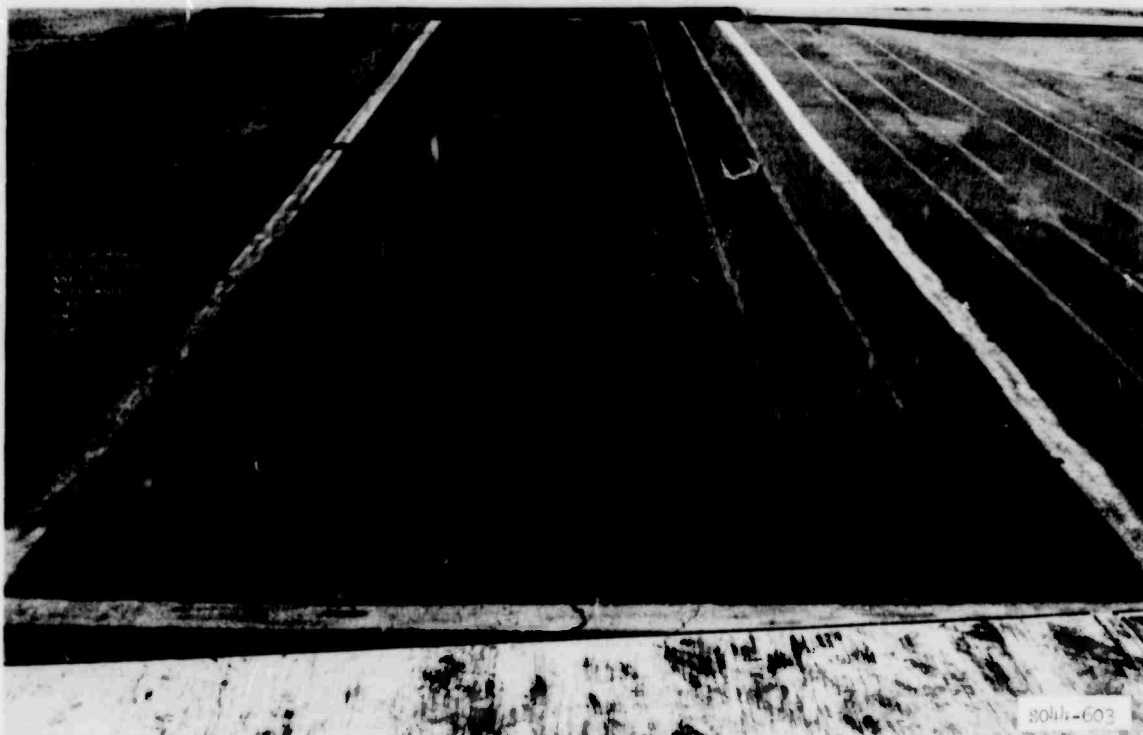
Photo B31. Failure of construction joint in item 2, lane 3
(after 90 coverages of 50-kip, single-wheel assembly)

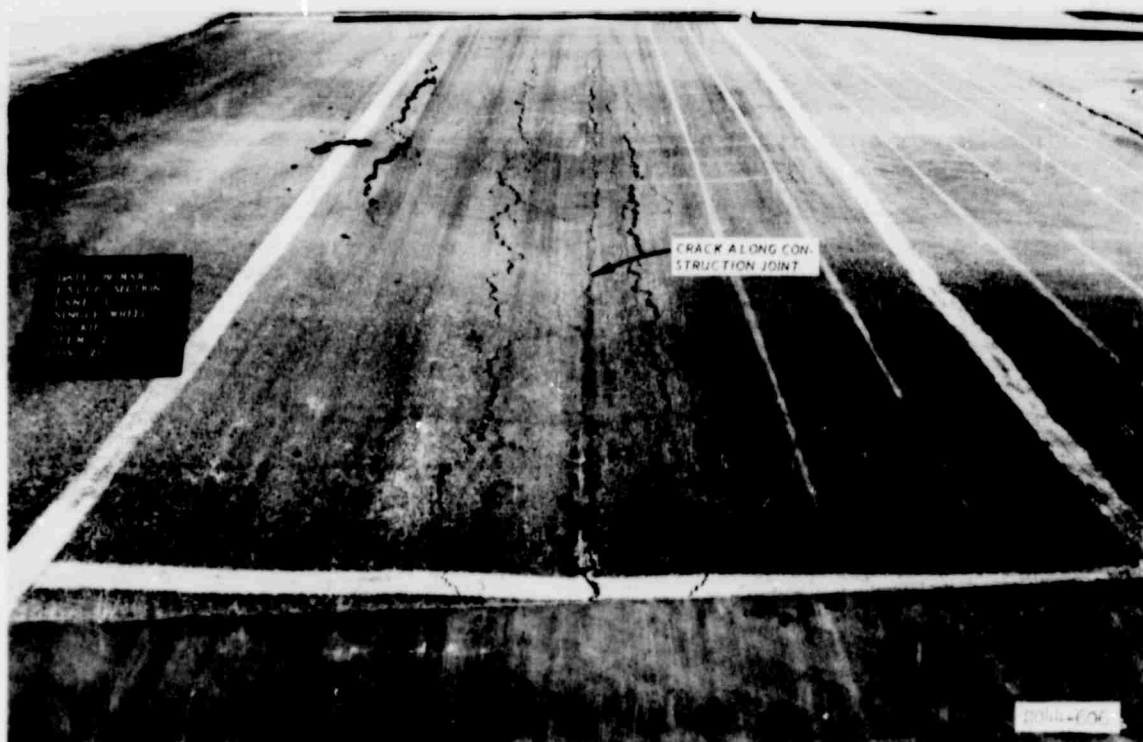
Photo B32. General view of item 2, lane 3, after 120 coverages
of 50-kip, single-wheel assembly

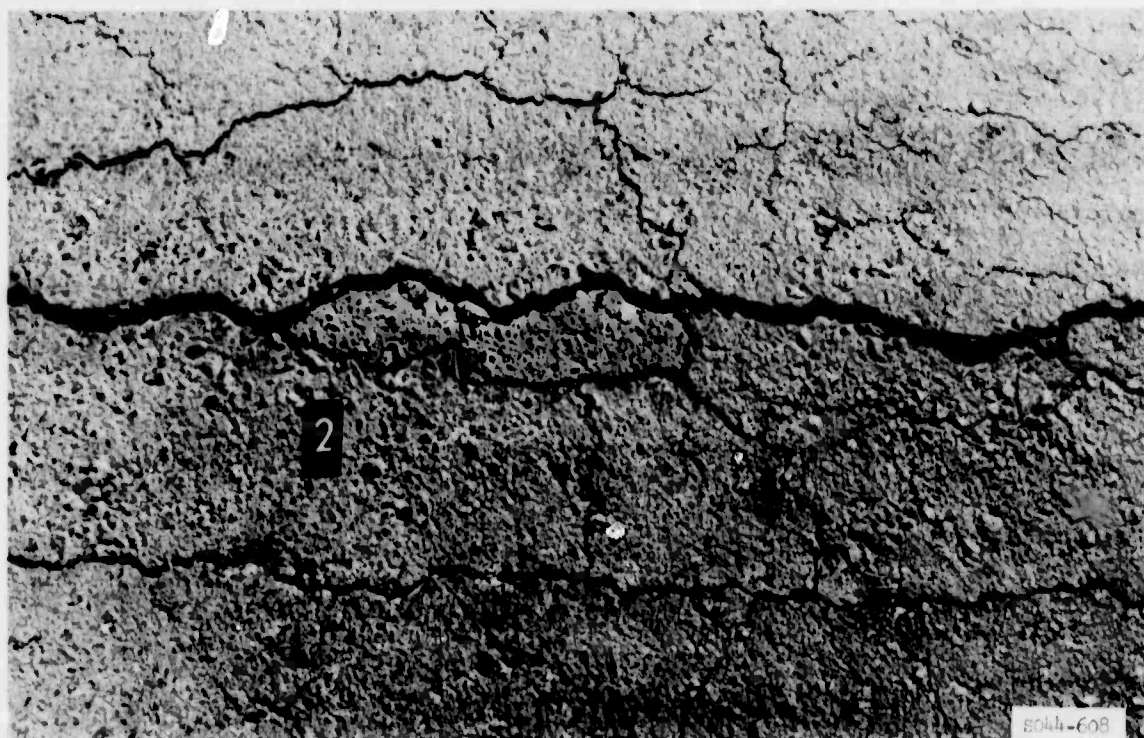
Photo B33. Close-up of severely cracked pavement in 100 percent coverage zone of item 2, lane 2, after 120 coverages of 50-kip, single-wheel assembly

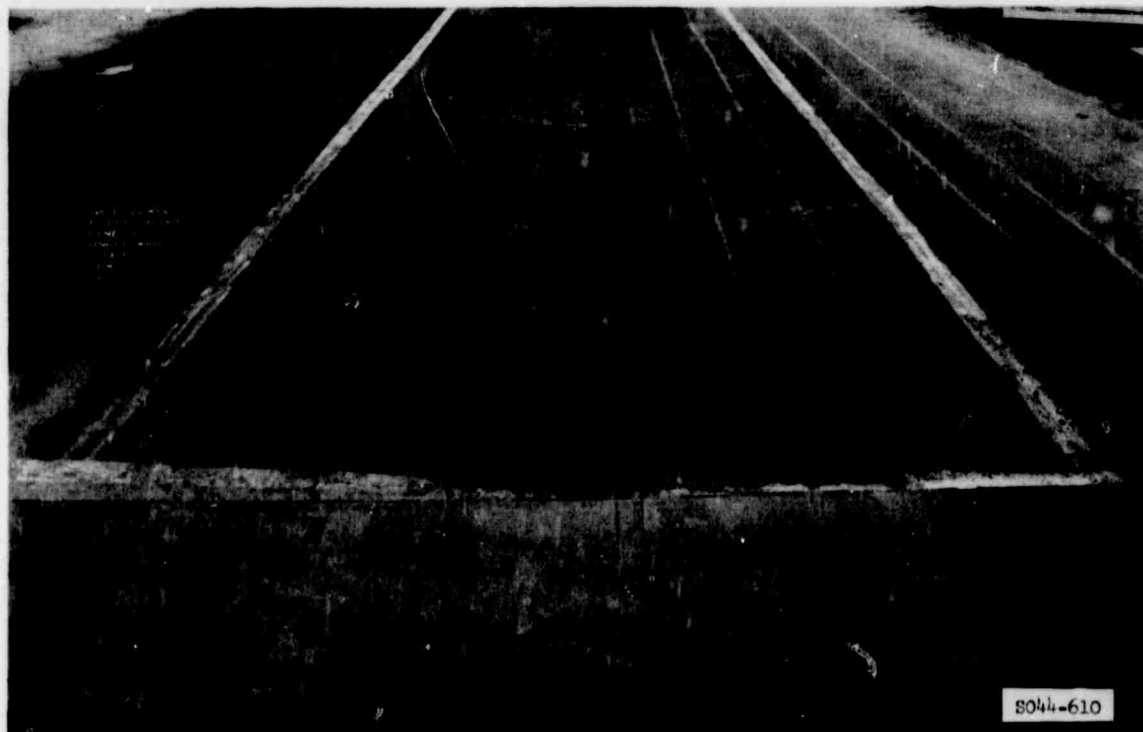
Photo B34. General view of item 3, lane 3, at failure (after 50 coverages of 75-kip, single-wheel assembly)

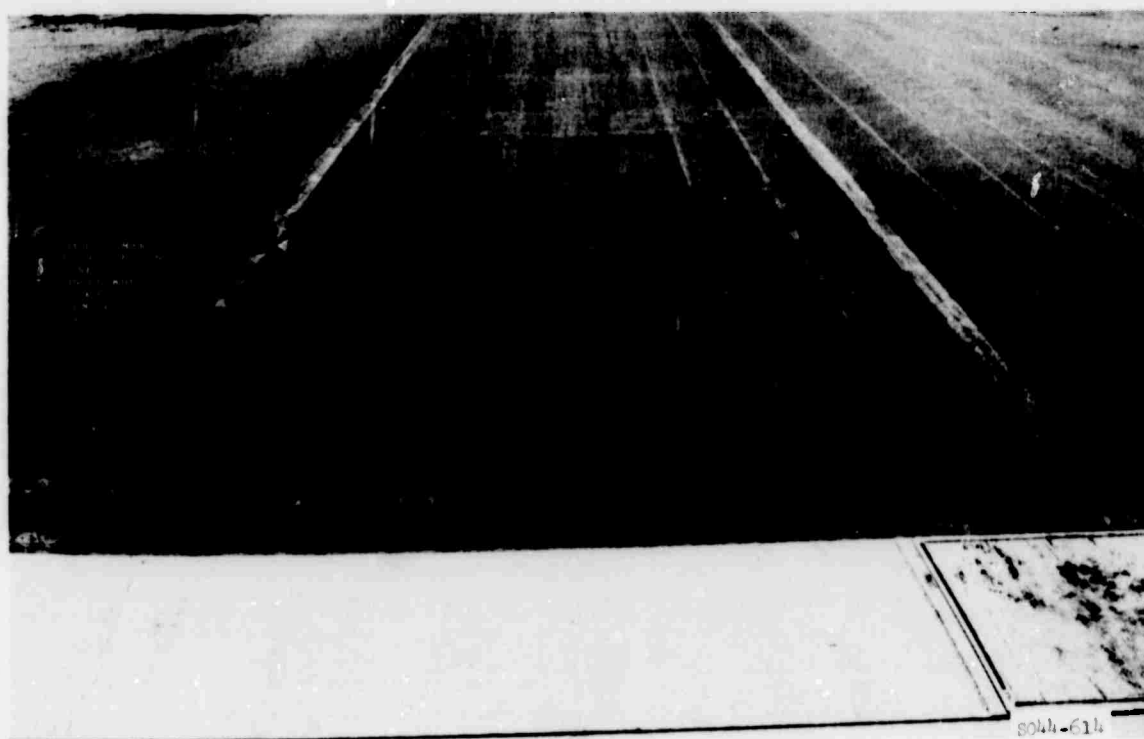
Photo B36. General view of item 4, lane 3, at failure (after 120 coverages of 75-kip, single-wheel assembly)

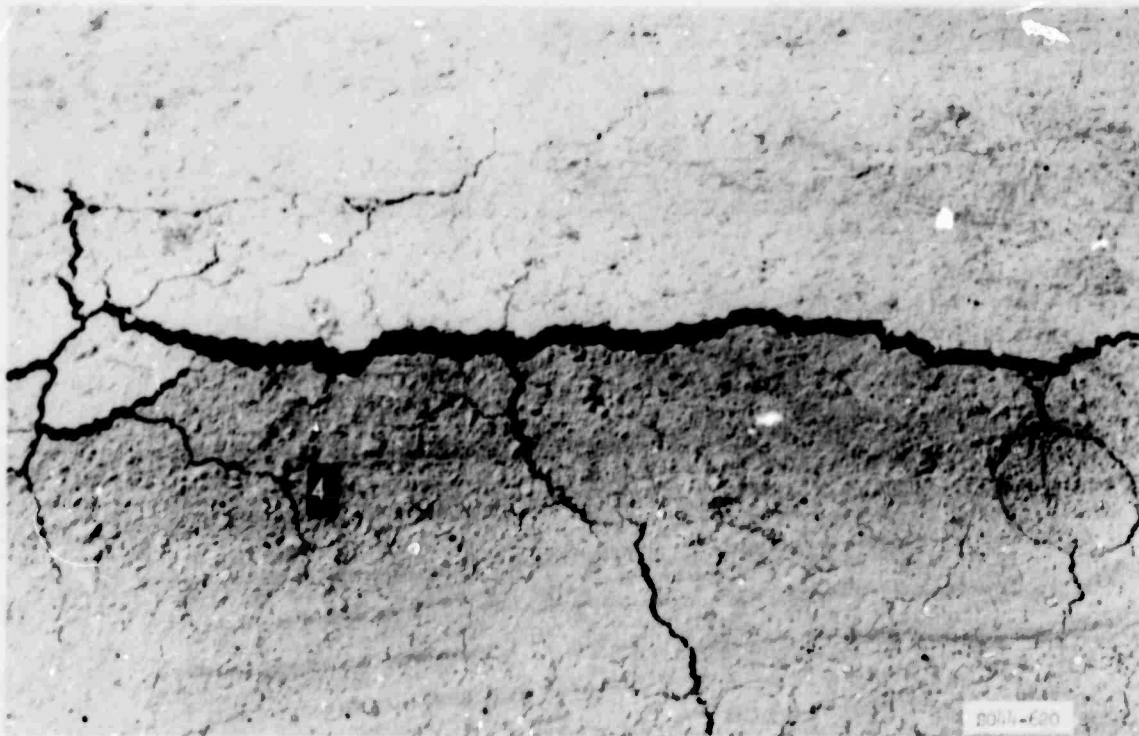
Photo B39. Severe cracking in the 100 percent coverage zone of item 4 at failure (after mixed traffic)
